**Site 12 Field Work Update
Westside/ Bayside/ North Point**

**NAVAL STATION TREASURE ISLAND
SAN FRANCISCO, CALIFORNIA**

**Base Closure Team Meeting
December 9, 2015**

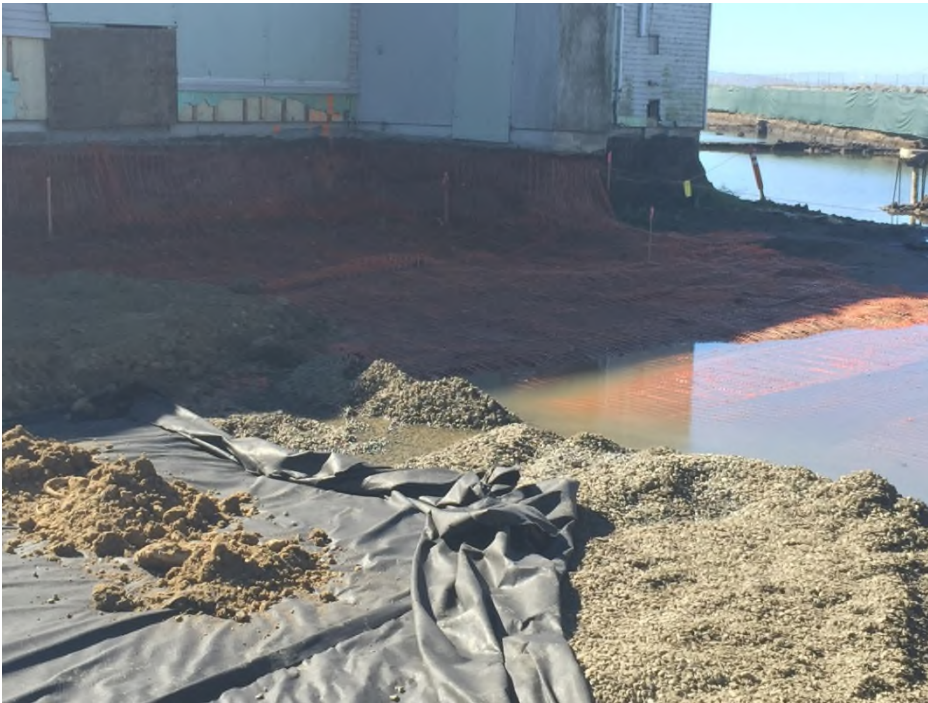
Survey Unit (SU) 1

Disposal Area North Point, Survey Unit 1

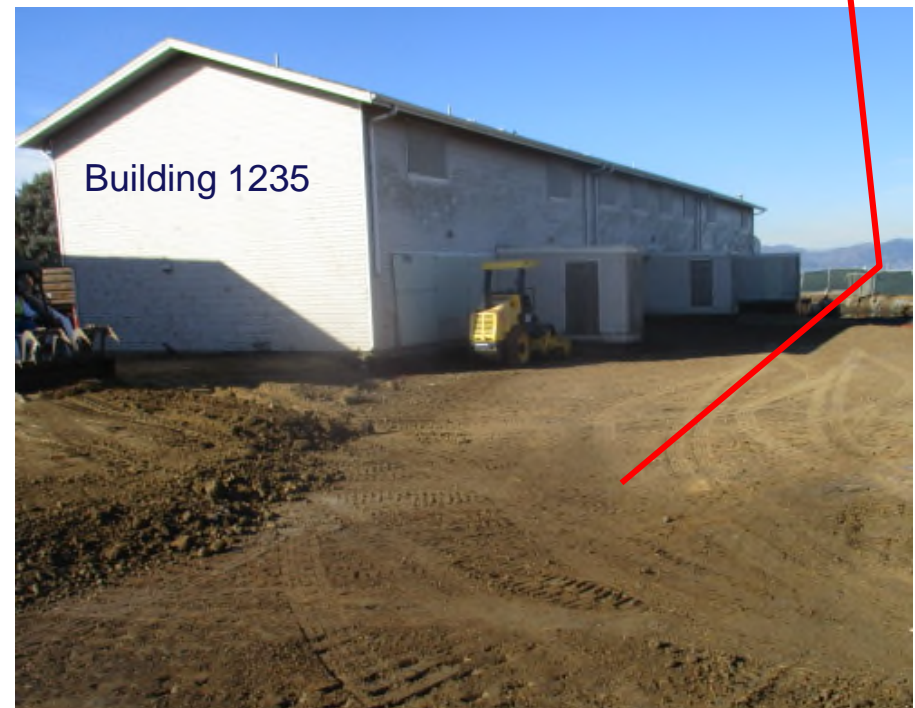
Disposal Area North Point (looking west) after backfill was completed

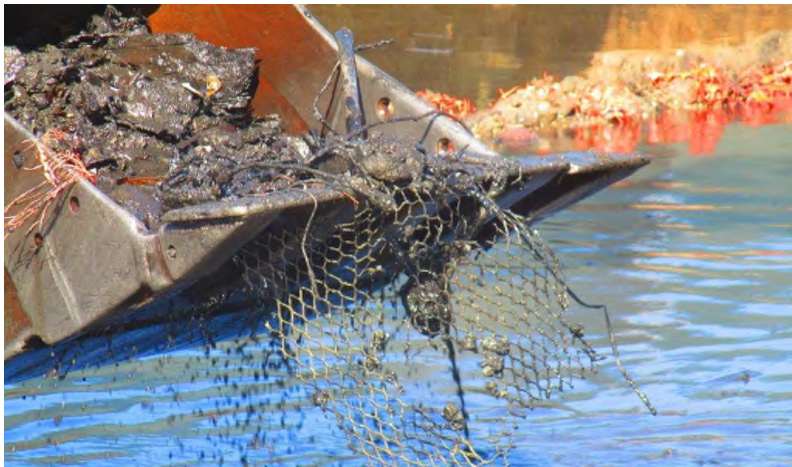
Removal of debris from deeper depths (4-12 feet below ground surface) at Disposal Area North Point.

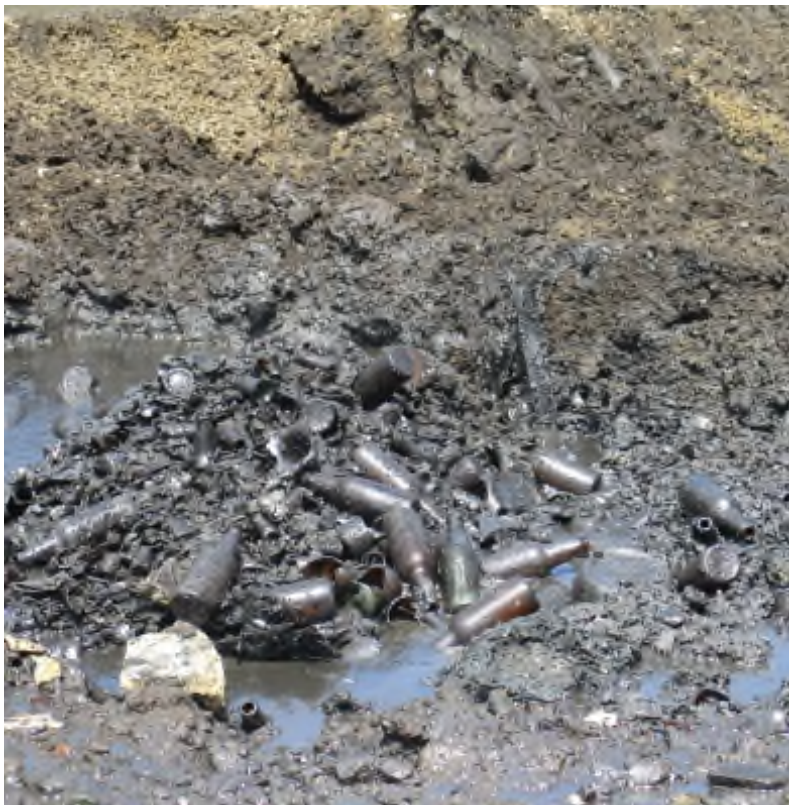
Debris found within "Historic Burn Area".

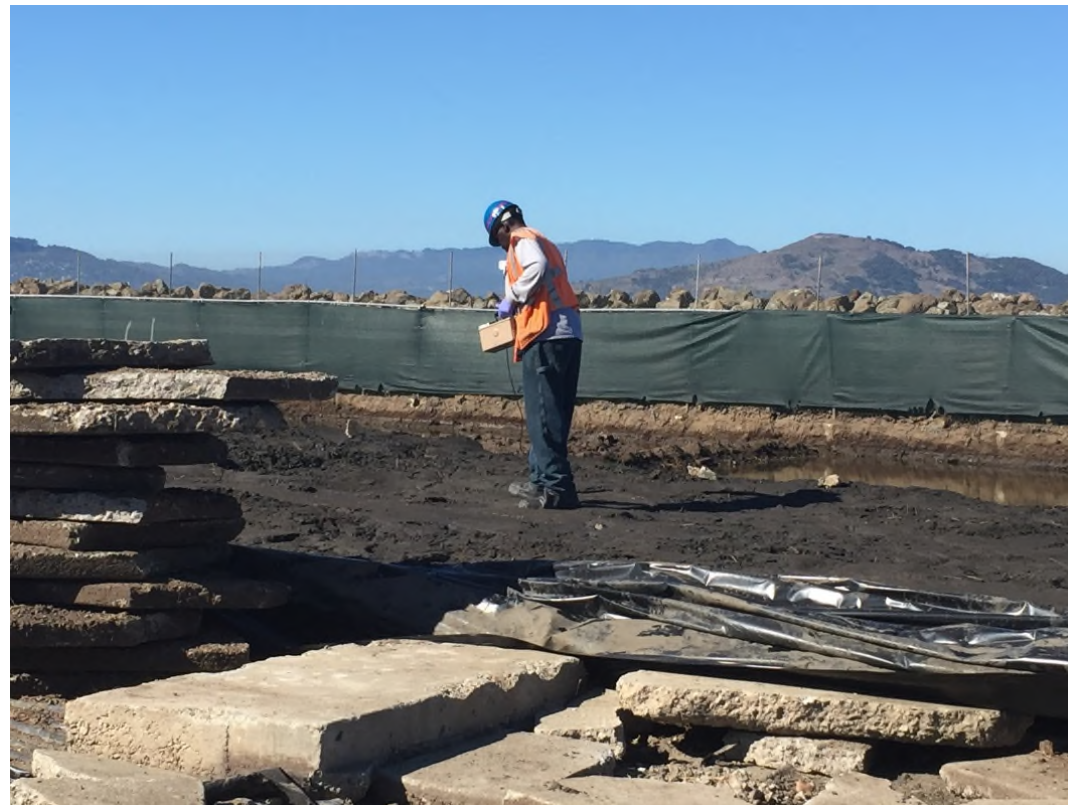
Radiological scanning of darker material from "Historic Burn Area"

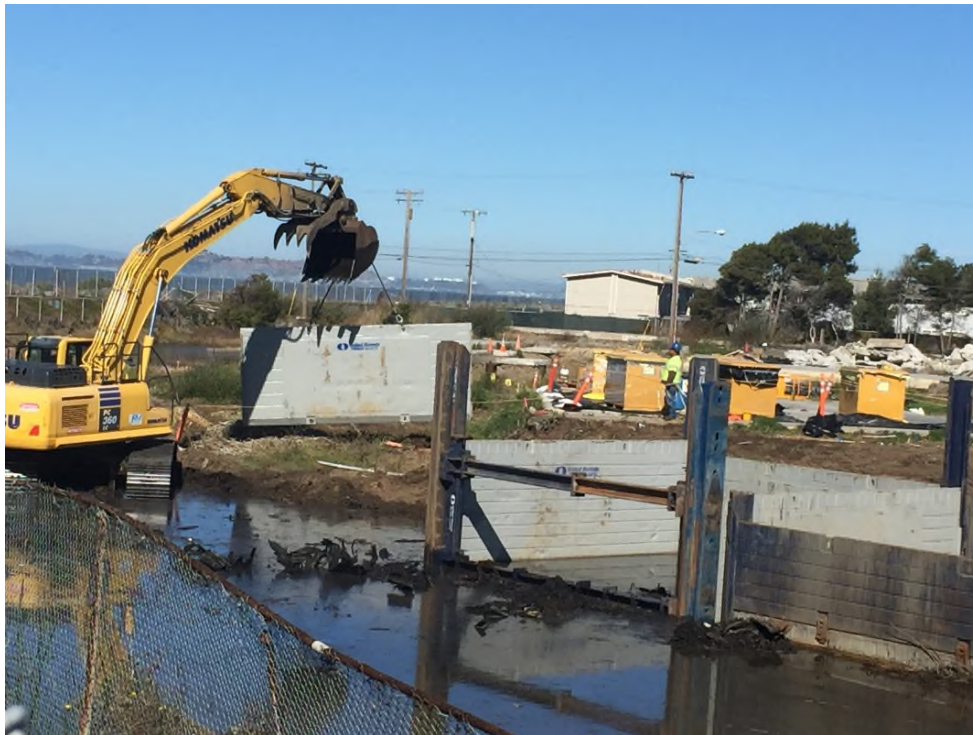
Installation of slide rail system to aid removal of waste deposited at depth (4-15 feet below ground surface) at Building 1321 Deep Waste Area.

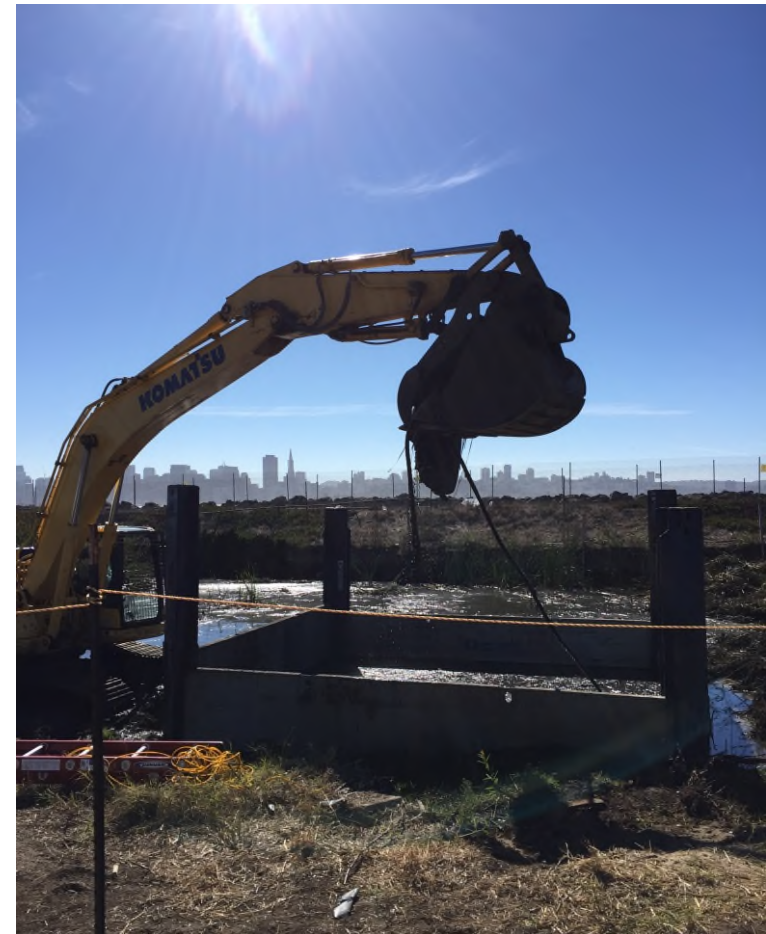
Excavation of cable and large metal pieces from within the slide rail "boxes" at Building 1321 Deeper Waste Area.

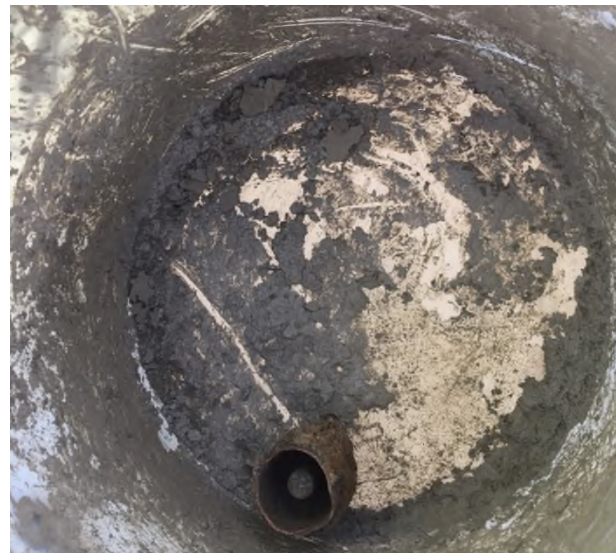
Left: 2" inch cartridge case in a 5 gallon bucket before venting

- 28 pieces of munitions debris have been found during the excavation work (to date)
- On November 19, munitions experts discovered a 2" inch cartridge casing that may have contained a primer
- The primer was vented prior to disposal

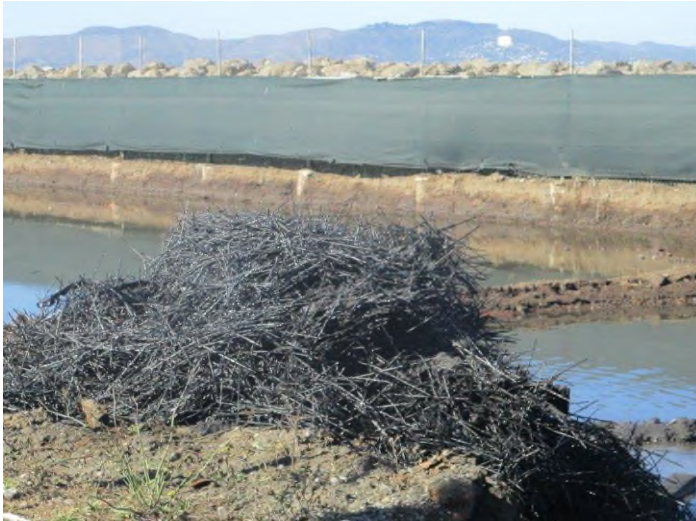
Welding rods removed from North Point from 4-12 feet below ground surface

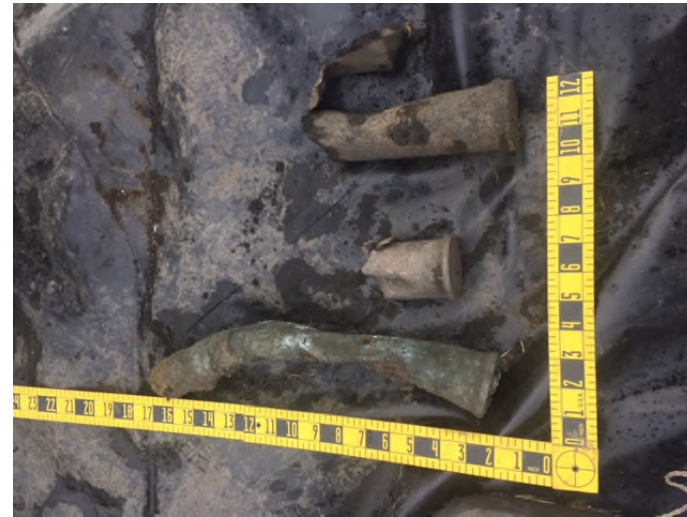
Munitions Scrap from Westside

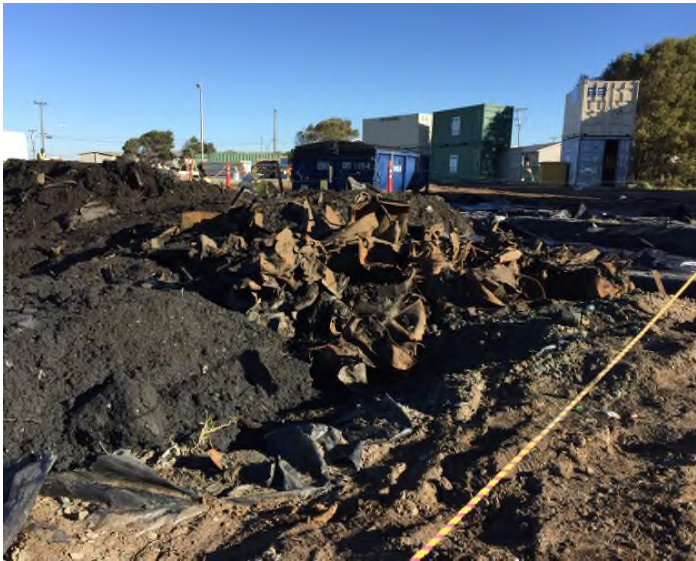
Large metal debris and cables removed from Deep Waste Area at Building 1321 at Westside.

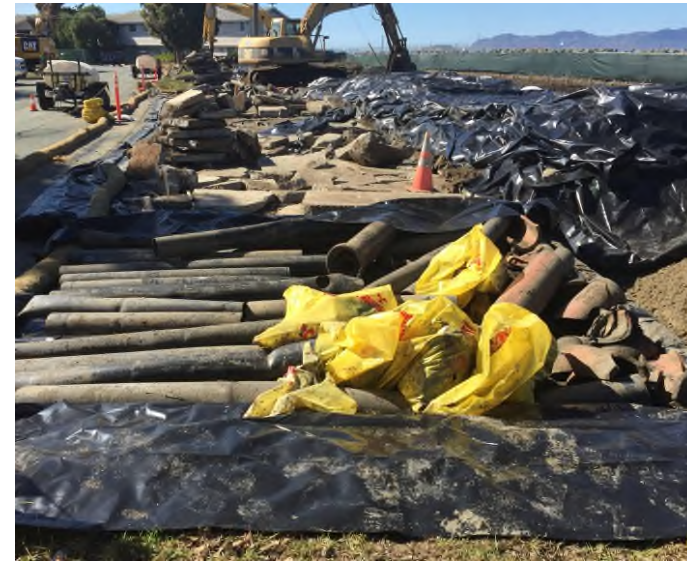
Sewer line piping, concrete and waste soils from North Point

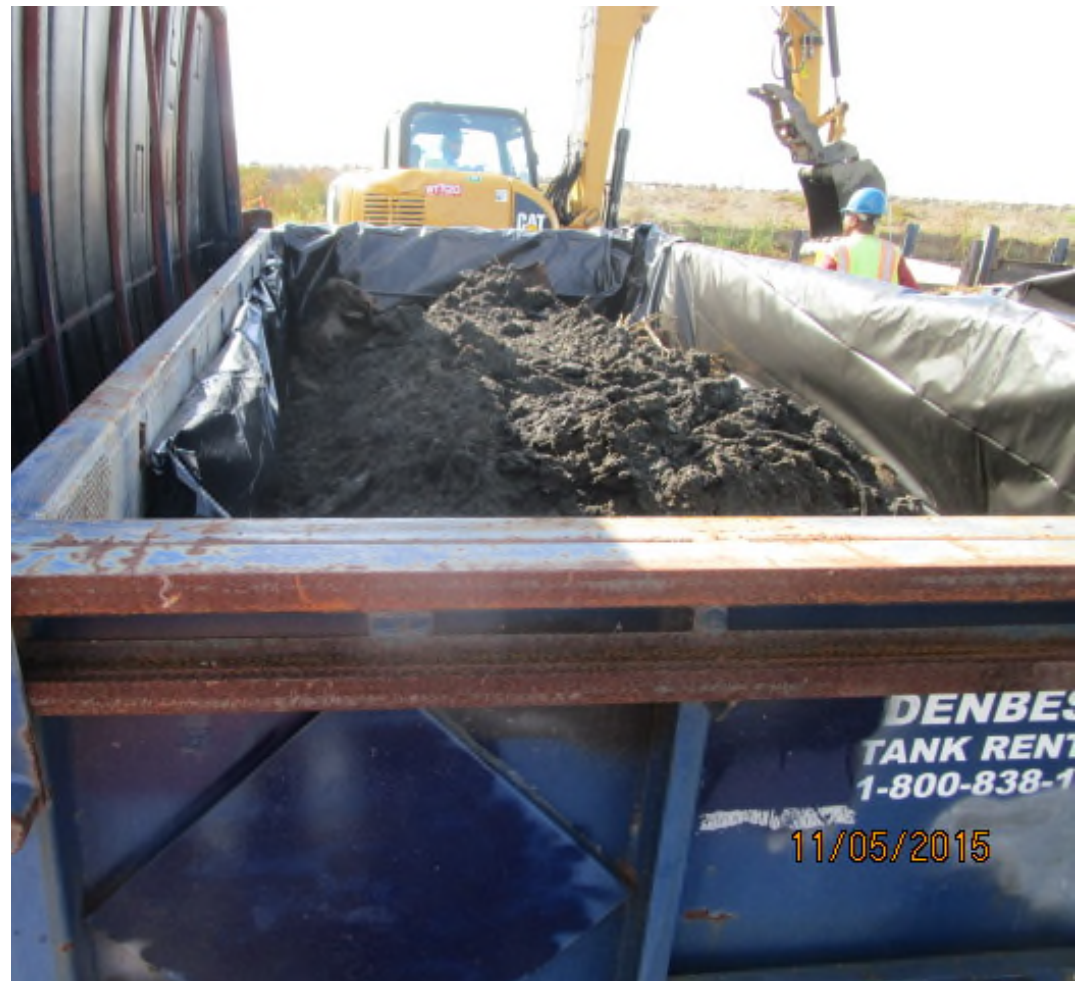
LLRW bins filled and ready for release to EMS for disposal

- 30 roll-off bins have been filled with LLRW since project start
- Navy's LLRW licensed waste broker (Environmental Management Services, Inc) handle shipping and disposal
- Bins typically get shipped to US Ecology's facility in Grandview, Idaho

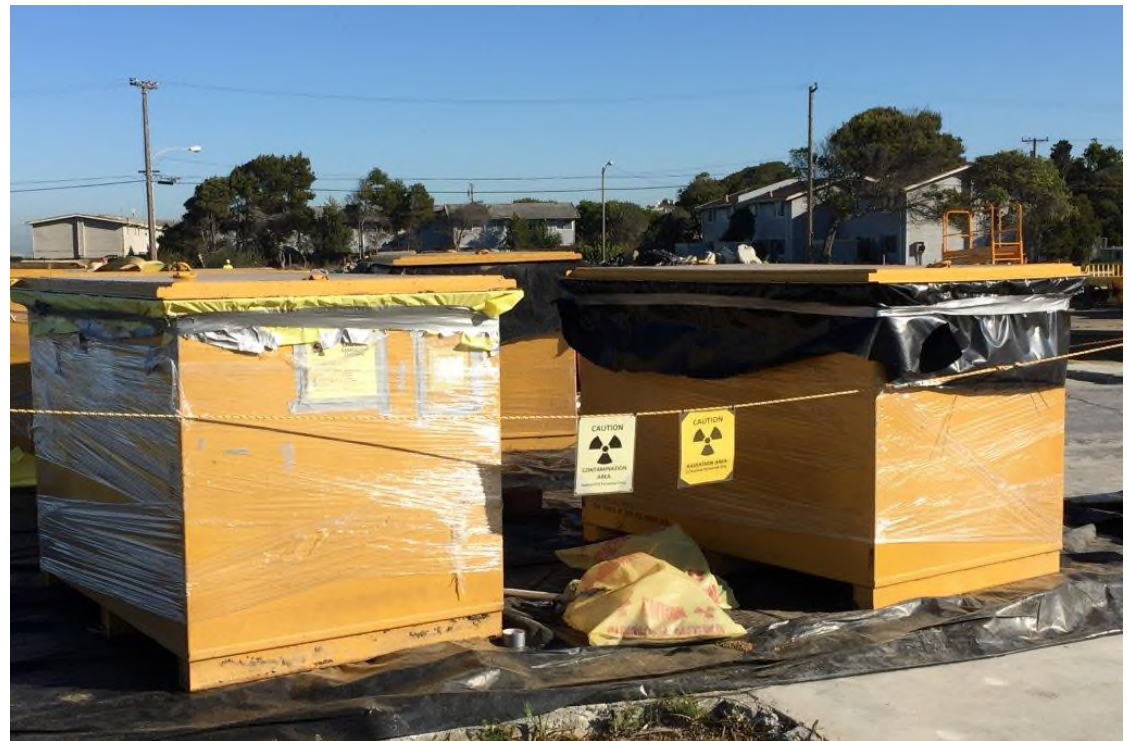
Processed Radiological Waste Storage Containers

- Five radiological waste containers were processed in October
- Containers have been transferred to (Environmental Management Services, Inc)
- EMS is preparing for shipment
- Waste containers are planned to be shipped to US Ecology
